**JOINT INSPECTION REPORT OF JCIFM's SUB-GROUP ON INUNDATION AND  
FLOOD MANAGEMENT ISSUES IN BORDERING AREAS OF NEPAL AND INDIA.**

**(June 26<sup>th</sup> -30<sup>th</sup>, 2018)**

**FIRST JOINT INSPECTION OF SUB-GROUP (26 to 30 JUNE, 2018)  
PHOTOGRAPHS OF SITE VISIT**

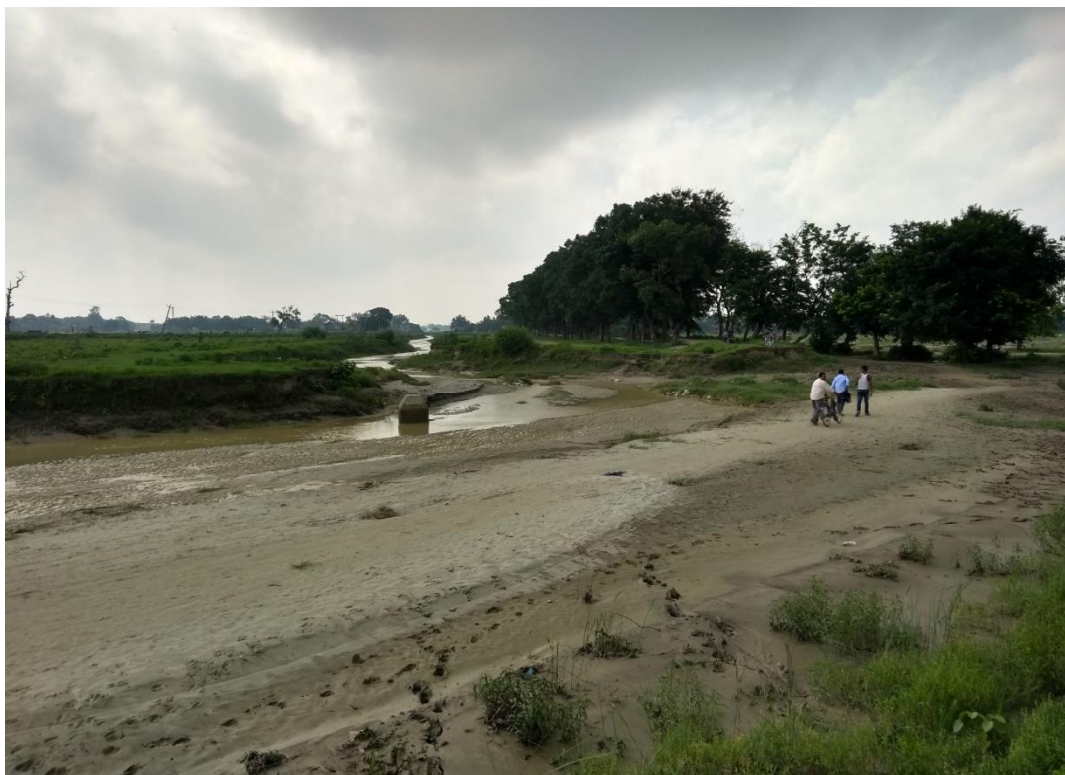
**Issues:** Due to non-availability of any defined channel of Khando river along the Indo-Nepal border, it causes flooding in the villages including those of Kunauli Bazar of Indian side. Hence, Indian side was forced to make low height bund along the border causing inundation in the upstream Nepali territory. This has become a cause of conflict between the people of both countries every year.

Fig.-1.1: Flow of River Khando to Jita river due to siltation of Khando river course

The channel of river Khando may be defined in line of Nepal up its confluence with river Bhaluahi. In addition to that the flow of JEETA may be redirected to Khando river near graveyard.

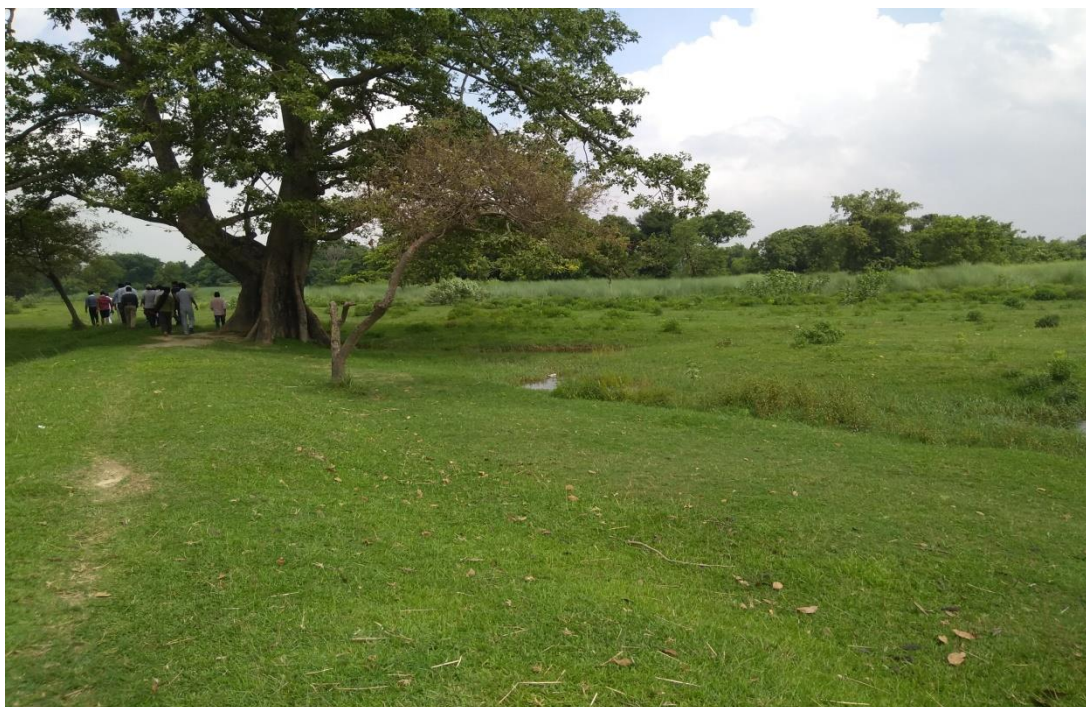
Fig.-1.2: Old course of Khando river

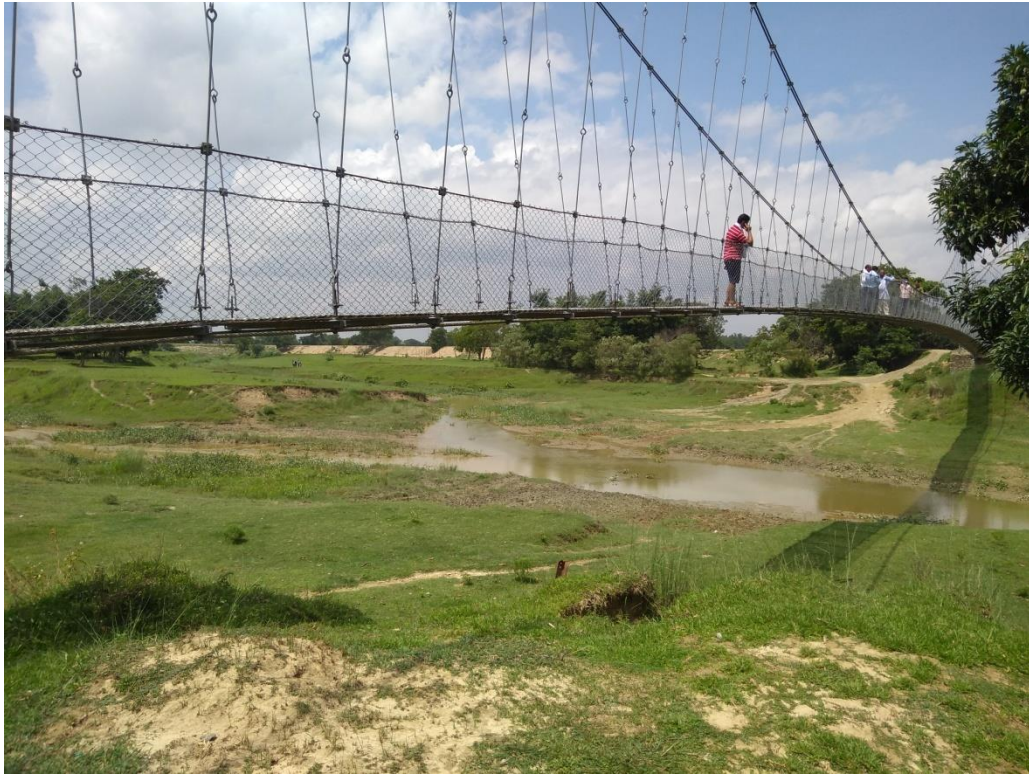
Fig.-1.3: Confluence of Khando river with Bhaluahi river

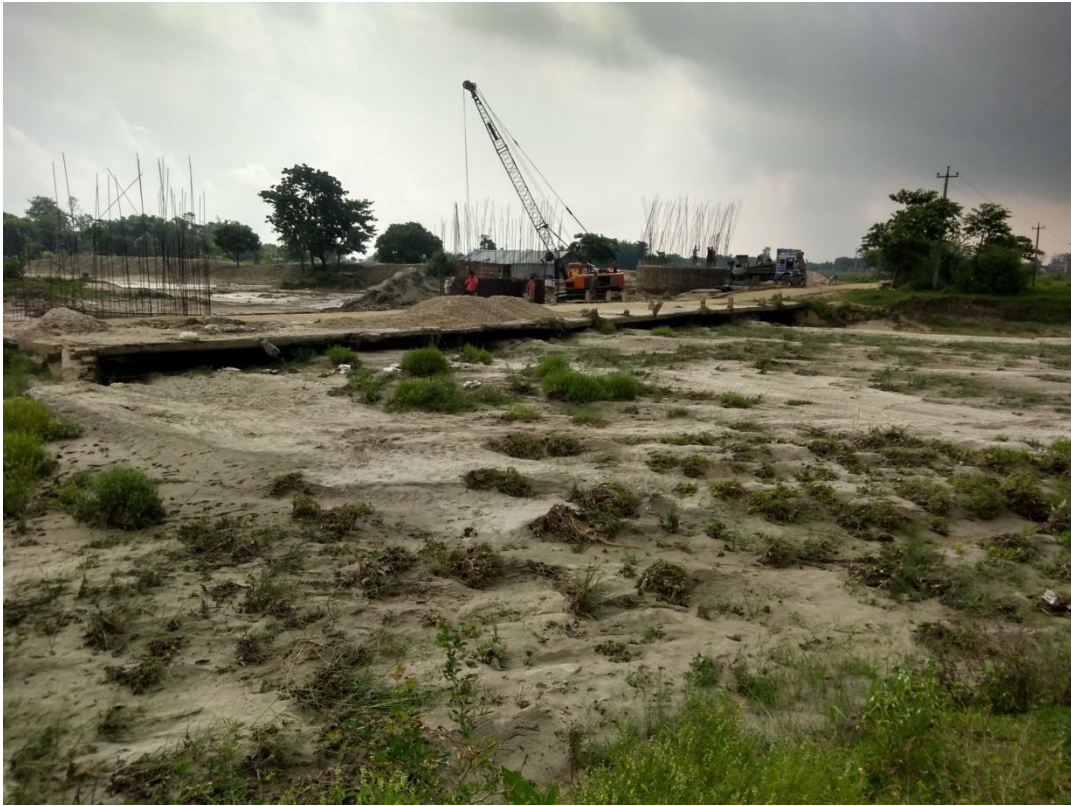
Fig.-1.5: Construction of Road bridge on Khando river in Nepal

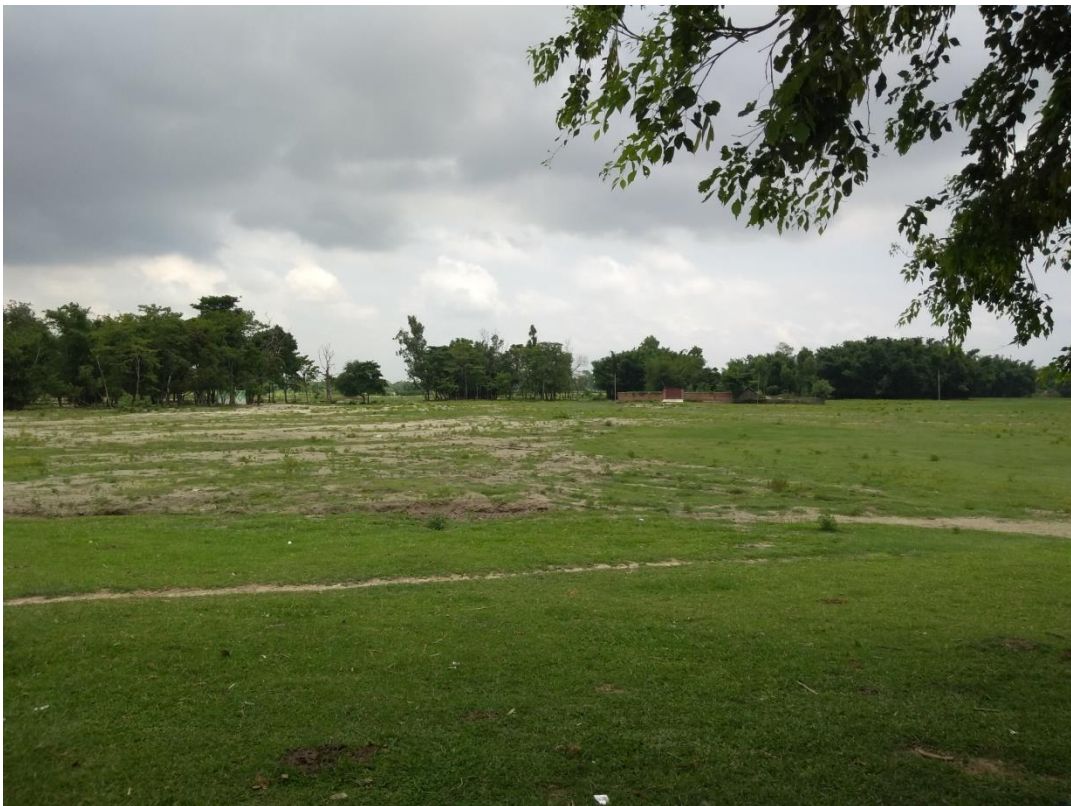
Fig.-1.5: Siltation on agricultural land of Kunauli, India by Khando river

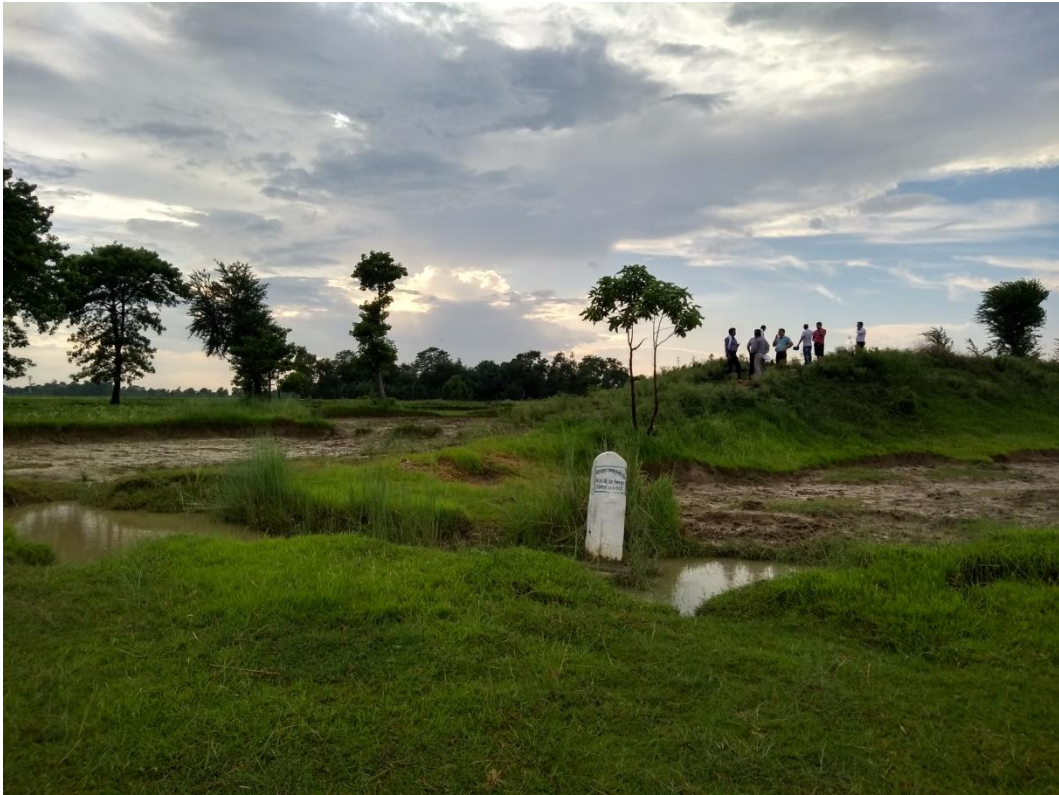
**Issues:** Due to non-construction of embankment near Indo-Nepal border, flood water passes through the gaps causing inundation in large area in Nepal and India near border during every rainy season. It was reported that tender for construction of embankment in the above mentioned has already been awarded.

Fig.-2.1: Gap after Zero RD of Kamla Left Embankment near No-man's land

**Possible Solution:** The construction of embankment near Indo-Nepal border may be completed at the earliest.

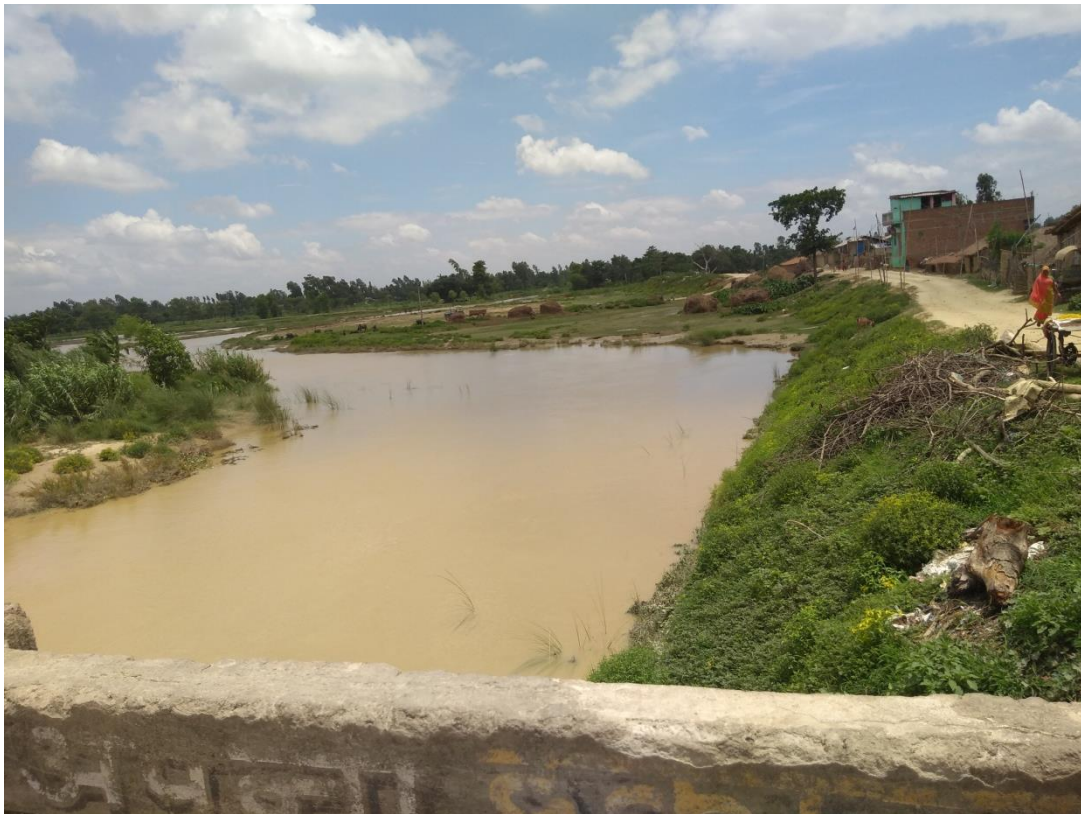
The right and left embankments in Nepali territory is constructed by the government of Nepal by People's Embankment Program office No.-2, Jaleshwor which reached up to the no-mans land. The left embankment of Indian side has been joined with the left embankment of Nepal but the right bank is not yet connected with the right embankment of Nepal causing flood in right bank covering whole Bhitamore bazar as well as inundation in Nepal.

Fig.-4.1: Rato Left Embankment near Bhattamore-Sitamarhi road

**Possible Solution:** The construction of right embankment in Indian side with AFS at suitable location should be expedited and tagging of embankment may be completed at the earliest.

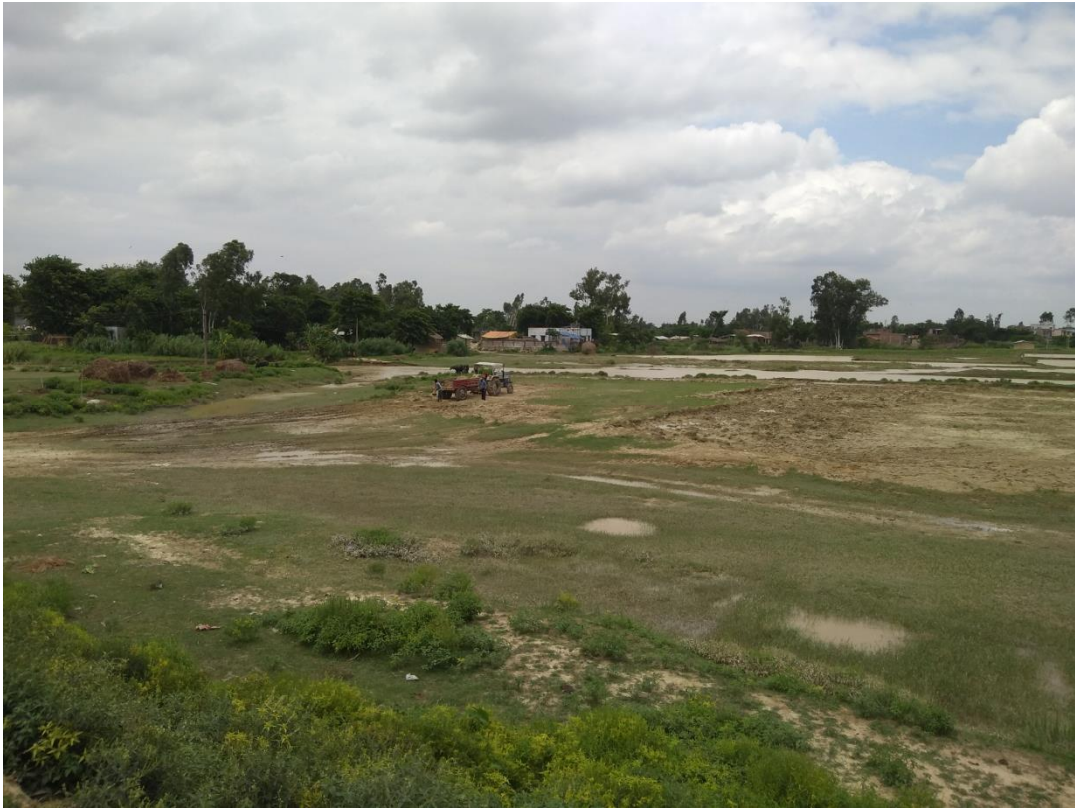
**Issues:** Due to incomplete work of tagging of right embankment of India and Nepal, in every rainy season the flood water rolls back to Nepali territory and submerges all the important government offices in Nepal. The flood water submerges the entire Bhitamore market, which is a densely populated area including SSB camp and Customs office in the Indian side. The opening of existing bridge on Bhitamore-Madhubani road is insufficient to pass flood water causing inundation problem in Nepali territory.

Fig.-4.2: Bhattamore bazaar at the mercy of Rato river

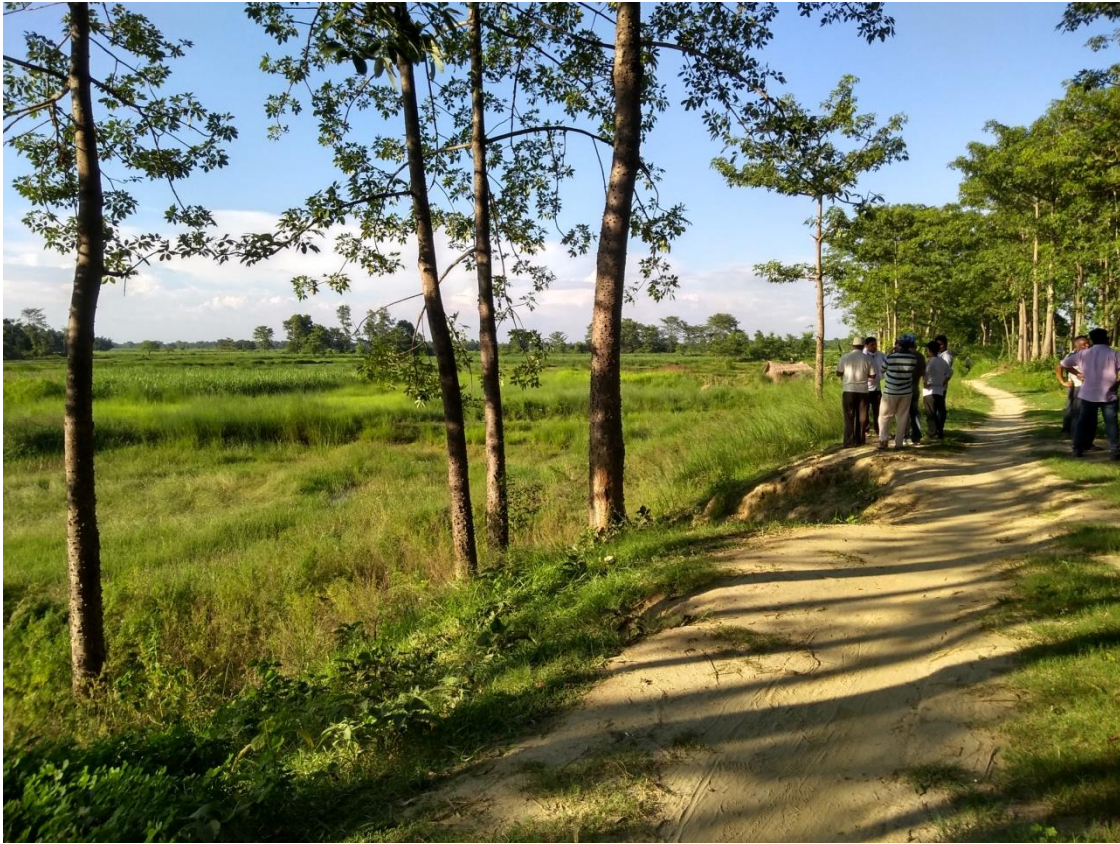
**Issues:** It was reported that flooding of the area has been checked after construction of Lakhandehi embankment. However, the sheet flow of Lakhandehi river has been obstructed by earthen bund causing inundation in Nepali territory due to insufficient passage of water resulting into damage of crops. It impacts severely the socio-economic status of the concerned Nepali people.

Fig.-5.1: Jamindari Embankment in India near Bara-Udhoran village, Nepal

**Possible Solution:** Additional AFS may be provided in the existing embankment, one at MURHAGHAT THANA NO.2, near SSB camp and second at east of Madhopur-Bara Udhoran road.

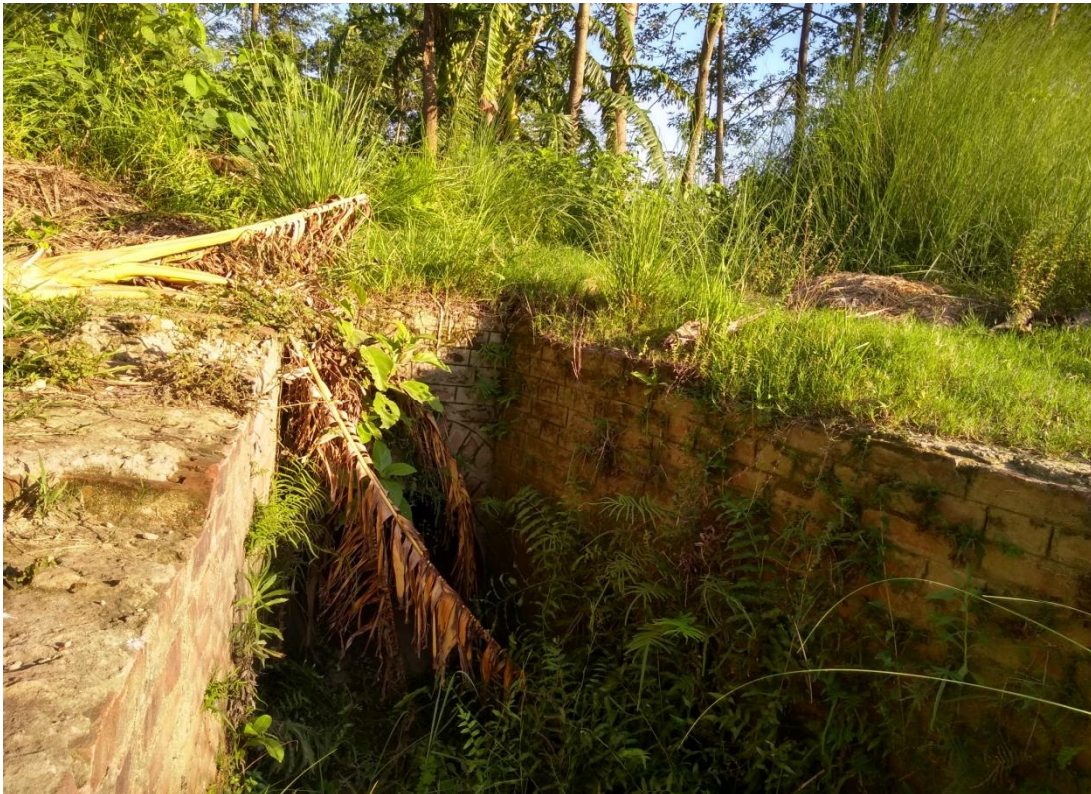
In the post lunch session on 28<sup>th</sup> June, 2018, the Sub-group visited the existing Jamindari embankment in Indian territory near Pakari, Bara-Udhoran village (near Indo-Nepal border). Then walked all through earthen embankment and inspected the small AFS whose gate was found missing. The Sub-group gathered in the nearby SSB office compound and enquired with the SSB personnel and local people.

Fig.-5.2: Small AFS on Jamindari Embankment near Bara-Udhoran village, Nepal

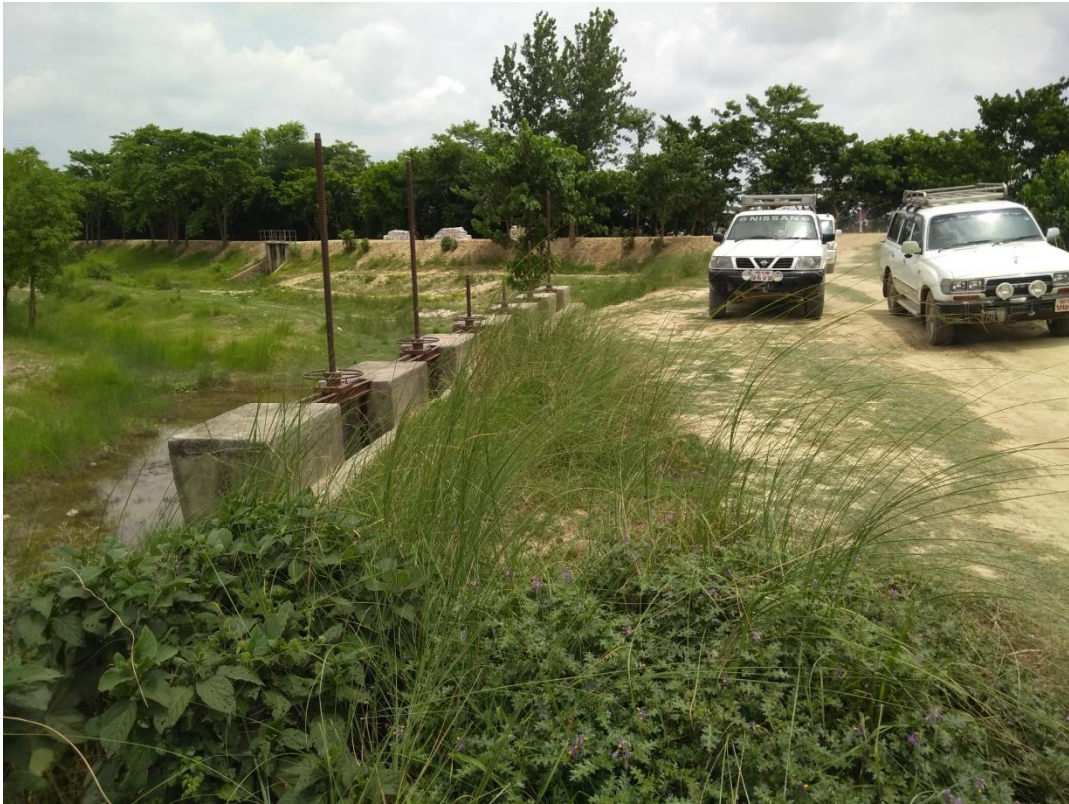
**Issues:** It was observed that two number of AFS (one completed and another to be constructed) have been provided in Lalbakeya Right embankment in Nepali territory. Whereas, the construction of embankment surrounding Guhabari village in Indian side has been done without providing any opening for the old course of the drainage channel. This has created inundation problem in Nepali territory. The existing bridge on railway line as well as on Guhabari-Bhawanipur road in between the earthen embankment and railway bridge show trace of the old course of channel.

Fig.-6.1: Gated AFS on Lalbakeya Right Embankment near border

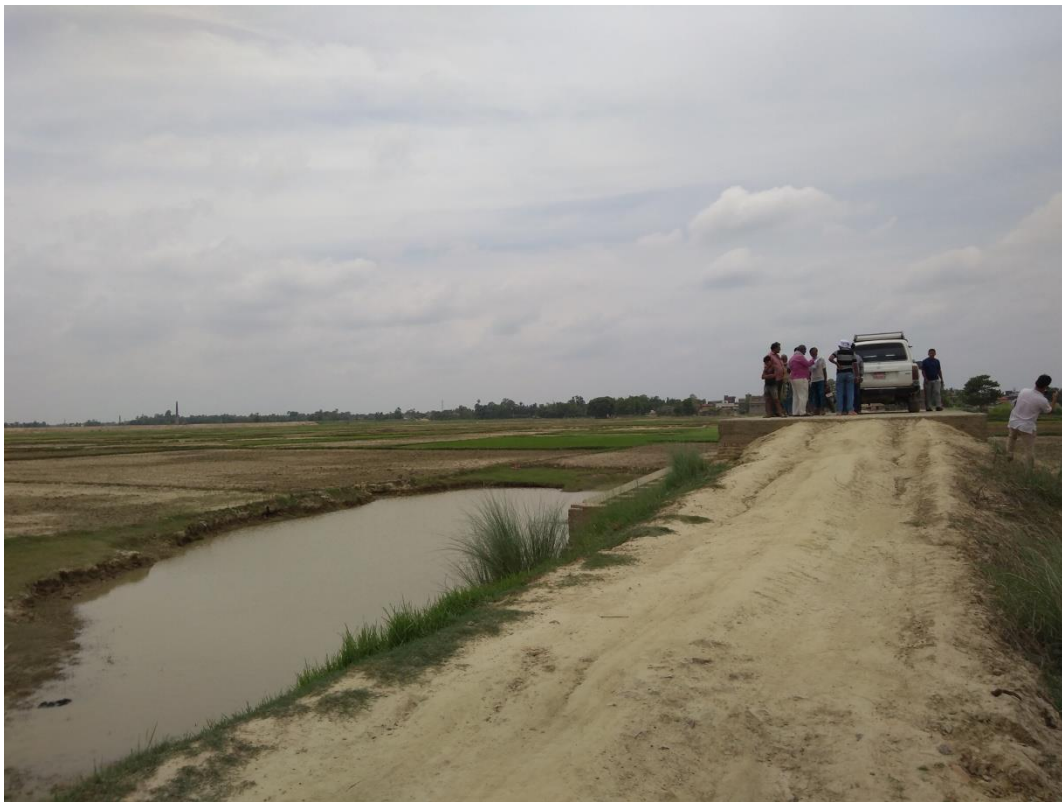
Fig.-6.2: Existing Culvert on Guhabari-Bhawanipur road in India

**Possible Solution:** Possibility of providing opening on the embankment in line of existing railway bridge and Guhabari-Bhawanipur road bridge may be explored.

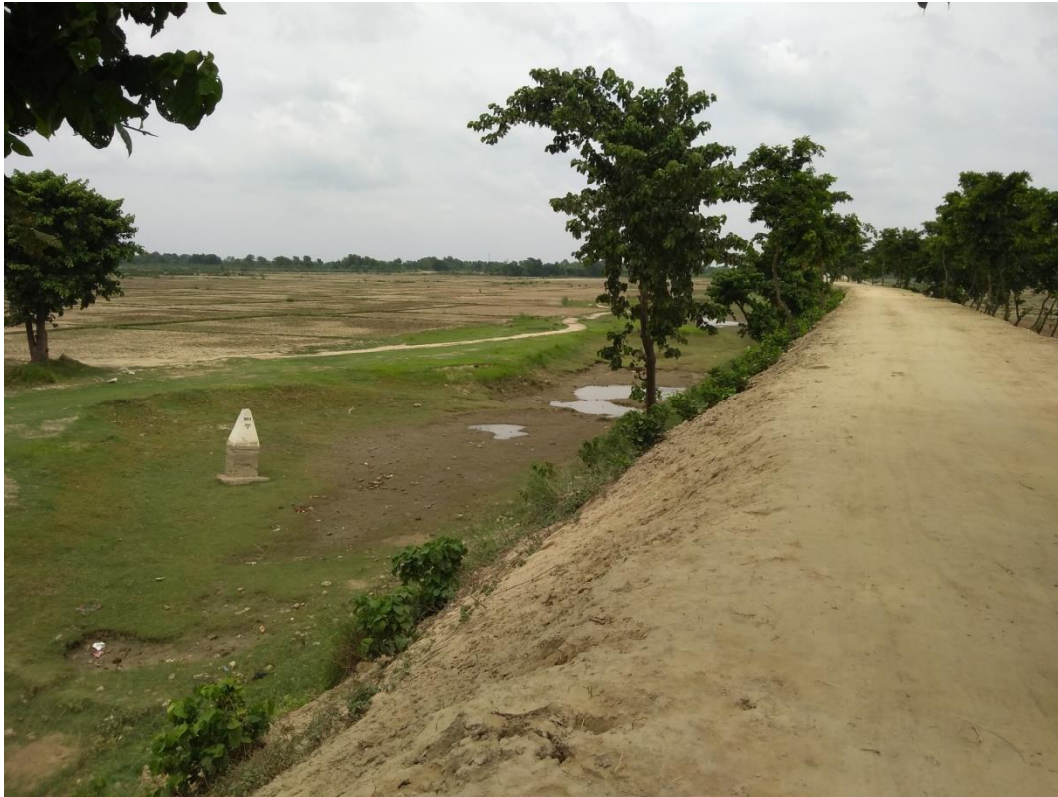
Fig.-6.3: Jamindari Embankment near Guhabari (India) & Banjaraha (Nepal)

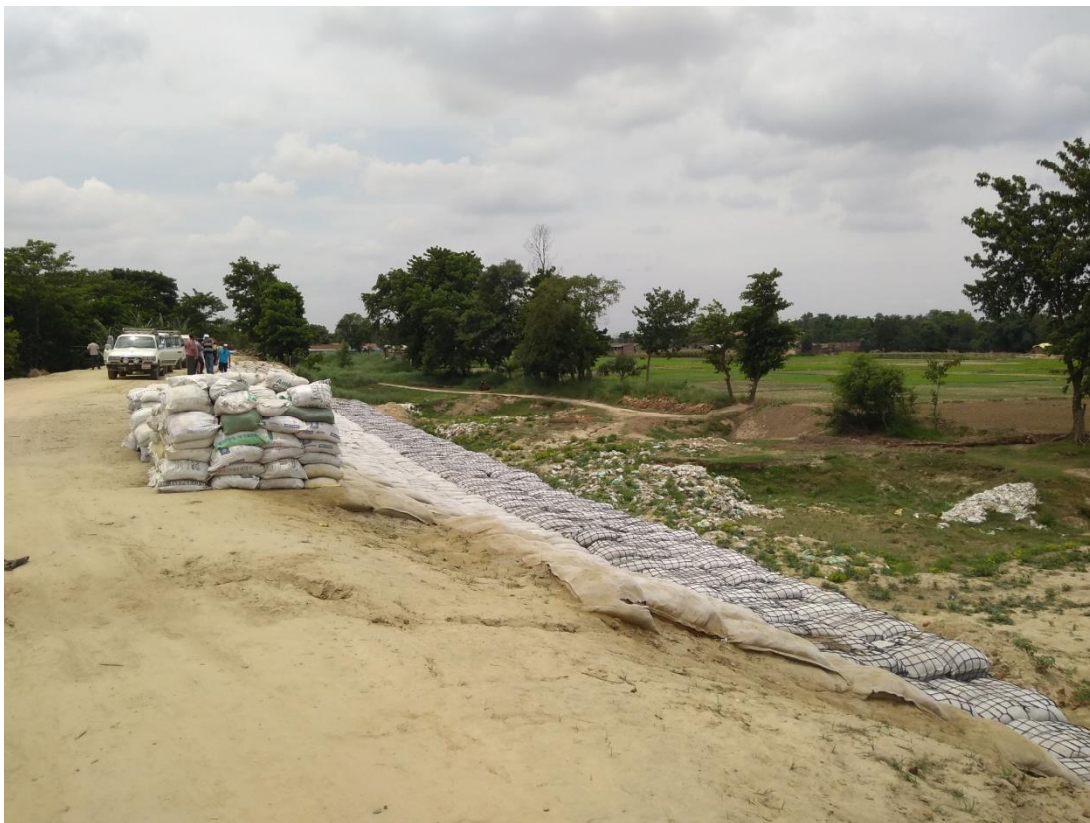
Fig.-6.4: Embankment protection work near Banjaraha village Nepal

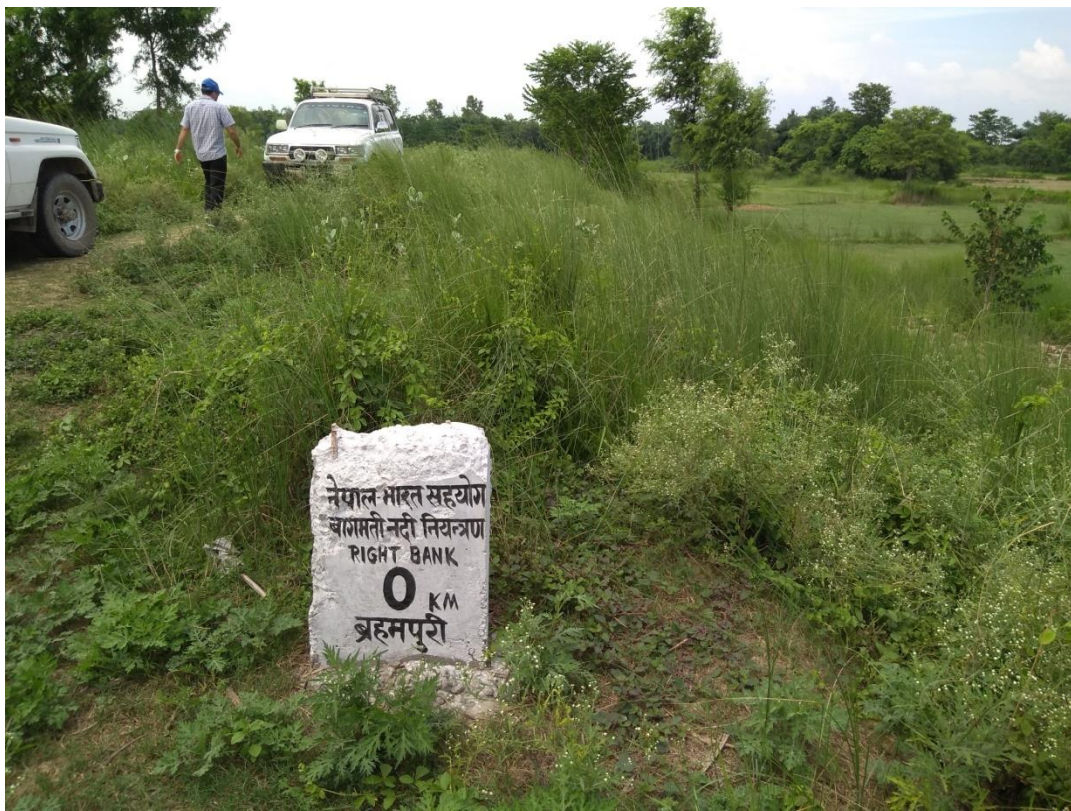
The Sub-group visited the right embankment of Bagmati river, near the no-mans land and inspected the area. The right bank has been terminated at the no-man's area and the further construction on Indian side has not commenced. This causes inundation problem in the Nepali territory and submerges the BRAHMPURI village of Nepal. The committee visited existing BAIRGINIYA RING BUND and gathered the information about the joining point of Bagmati right bank in Indian territory.

**Issues:** The onward embankment on the Indian side needs to be constructed which would tag the existing embankment in Nepal with the ring bund of Bairginiya.

Fig.-7.1: Zero RD of Bagmati Left Embankment in Nepal portion

**Possible Solution:** The construction work of right embankment in Indian side should be expedited and to be jointed with embankment of Nepal which has terminated at the no-man's land.
